BRAKTOOTH: Causing Havoc on Bluetooth Link Manager

VULNERABILITY DISCLOSURE REPORT

August 31, 2021

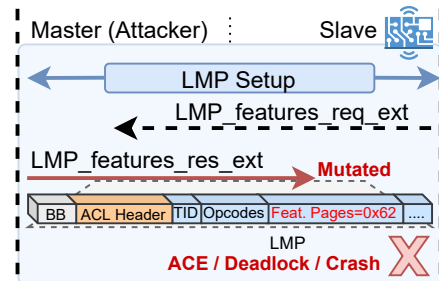
Figure 6: Feature Page Execution

Impact: The attacker is able to execute arbitrary functions implemented in the target ESP32’s firmware. Once the attacker acquires a dump of ESP32 firmware and the memory layout is known, functions at arbitrary addresses can be called.

This allows the attacker to erase user data (NVRAM), call I/O functions that may control actuators, etc. Triggering firmware crashes or a BT deadlock is also possible during repeated attack attempts by executing invalid function addresses. In case of a deadlock, the user needs to manually reset ESP32 to restore BT communications.

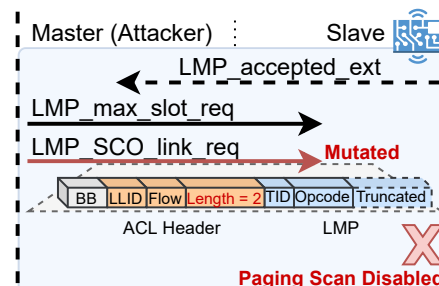
Figure 7: Truncated SCO Link Request

The Bluetooth Classic implementation in the Zhuhai Jieli AC6366C BT SDK 0.9.1 and earlier [33] does not properly handle the reception of truncated LMP_SCO_Link_Request packets while no other BT connections are active. This allows attackers in radio range to prevent new BT connections (disabling the AC6366C inquiry and page scan procedures) via a crafted LMP packet. The user needs to manually perform a power cycle (restart) of the device to restore BT communication. Following Figure 7, the attack can be launched by sending an *LMP_SCO_Link_Request* with *ACL length=2* instead of its normal size of 7.

Impact: The attacker is able to prevent external parties to connect to the device, requiring the user to manually perform a power cycle on the device to resume normal connectivity. Attack risk is reduced if the user is already connected to AC6366C or similar chipsets that only allow one active BT connection at a time.

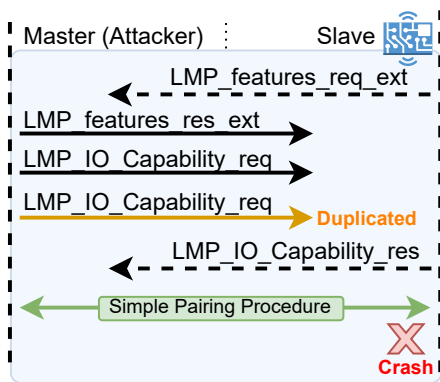
Figure 8: Duplicated IOCAP

The Bluetooth Classic implementation in Espressif ESP-IDF 4.4 and earlier [7] does not properly handle the reception of multiple *LMP_IO_Capability_req* packets during the *pairing process* (see Figure 8). This allows attackers in radio range to trigger memory corruption (and consequently a crash) in ESP32 via a replayed (duplicated) LMP packet. The issue was raised due to the sudden disconnection of ESP32 while its bluedroid host stack was still in the pairing process. The patch provided by Espressif rectifies this issue by handling a sudden disconnection during the pairing procedure (c.f., Table 5).

Impact: The attacker can exploit this vulnerability to promptly cause firmware crashes and therefore maintain a DoS while the attack is taking place. Since ESP32 restarts its firmware by default upon receiving a fault, no user interaction is needed to restore BT communication after the attack is stopped.

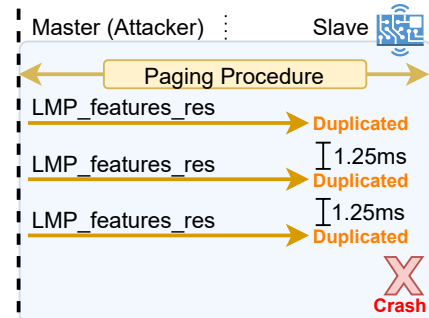
Figure 9: Feature Response Flooding

Impact: The attack triggers a firmware crash on ESP32 and a shutdown on **JBL TUNE500BT** and **Xiaomi MDZ-36-DB**.

In the case of a shutdown, the user needs to manually power on the device again to restore communication. Furthermore, since all targets accept multiple BT connections, the attack can also be triggered while the target is already connected to another device. For example, it is possible to immediately stop audio from playing on **JBL TUNE500BT** and **Xiaomi MDZ-36-DB**. The attacker, however, needs to know the BDAAddress of the target to launch the attack.

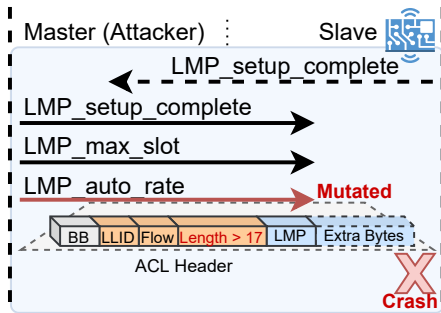
Figure 10: LMP Auto Rate Overflow

Impact: The attack causes a firmware crash on both **WT32i** and **AC6905X**. This can be used to cause a sporadic denial of service (DoS) attacks on such devices.

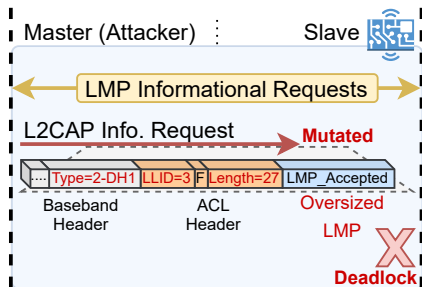
Figure 11: LMP 2-DH1 Overflow

The Bluetooth Classic implementation on Laird CSR8811 A08 [23] and CSR8510 A10 [22] SoCs allows an LMP length overflow over 2-DH1, resulting in a Deadlock (state machine or packet handler corruption) outcome. Figure 11 captures the sequence of messages exchanged to expose this vulnerability.

In particular, the attack is performed by changing the transport type of the normal LMP packet to *2-DH1* and then adding more bytes to the LMP payload. This, for example, results in a total ACL length of 27.

Impact: The attack causes a BT deadlock on Laird CSR8811 and a firmware crash on CSR8510 operating as a standard BT dongle. While the dongle firmware crash is automatically recovered by the OS, the deadlock requires the user to perform a power cycle to restore normal BT communication. The attack does not affect Bluetooth Low Energy (BLE) communication in CSR8811.

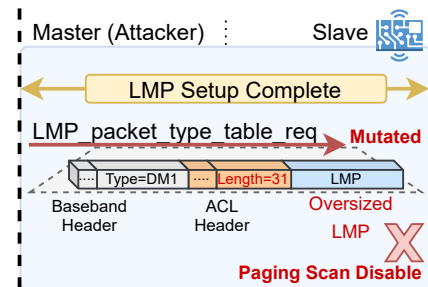
Figure 12: LMP DM1 Overflow

and hence blocks new connections. If the user is already connected to AB5301A and the attack is started (multiple BT connections are allowed), the active connection is not disrupted, but new connections or reconnection is not possible. As compared to V5 (Section 8.5), this attack works with any overflowed LMP packet rather than a specific LMP packet.

Impact: The impact of this attack is similar to V2 (Section 8.2), in which connections to the target are not accepted due to the page scan procedure being disabled after the attack (see Figure 1). Therefore, the user needs to manually perform a power cycle (restart) of the device to restore normal BT connectivity.

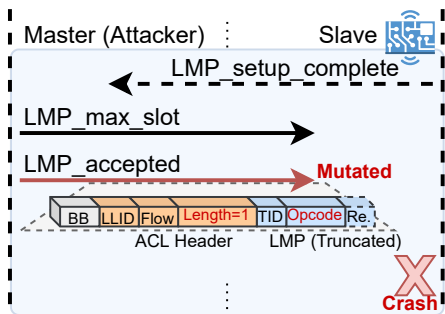
Figure 13: Truncated LMP Accepted

As the BT implementation of the target is closed source, the exact root cause of this vulnerability is not known. However, it is common that LMP procedures involving slot and rate adjustments are usually implemented in an interrupt handler different than other non-real-time LMP packets, such as feature requests and version requests. Such a handler may miss some checks which are present on the other handlers, explaining why some overflow/underflow attacks only work for certain LMP packet opcodes. This split in the LMP handler is present, for instance, in ESP32 BT implementation.

Impact: The impact is a denial of service due to a firmware crash & restart. The overall risk of such an attack is reduced if

AC690X and AC692X do not allow multiple BT connections. In such a scenario, the attacker could only trigger a firmware crash when no user is connected to AC690X or AC692X.

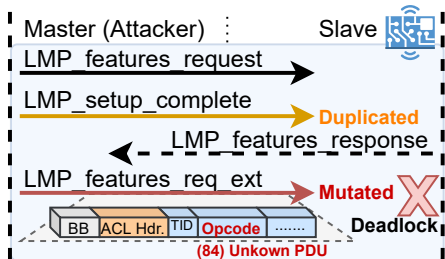
Figure 14: Invalid Setup Complete

This scenario is illustrated in Figure 14. The attacker sends an unexpected (duplicated) *LMP_setup_complete*, followed by a malformed *LMP_features_req_ext* with an invalid LMP opcode such as 0x64. The behaviour seen in Figure 14 allows attackers in radio range to deadlock a device via injecting crafted LMP packets. Moreover, the user needs to manually reboot the device to restore communication.

Impact: An attacker can exploit this vulnerability to perform a DoS. The overall risk of such an attack is reduced if AC690X and AC692X do not allow multiple BT connections.

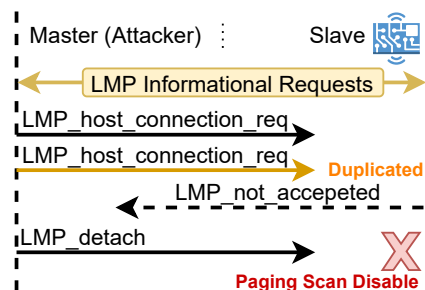
Figure 15: Host Connection Flooding

handle the reception of multiple *LMP_host_connection_req* as shown in Figure 15. This allows attackers in radio range to trigger a denial of service (deadlock) if no user is connected to the target. Manual user intervention is required to restart the device and restore Bluetooth communication.

Impact: An attacker in radio range can exploit the vulnerability to perform DoS and shutdown or restart products using chipsets and products based on Actions ATS2815/ATS2819. However, the impact of the attack is reduced as the vulnerability is only exploited when no other user device is connected to the target.

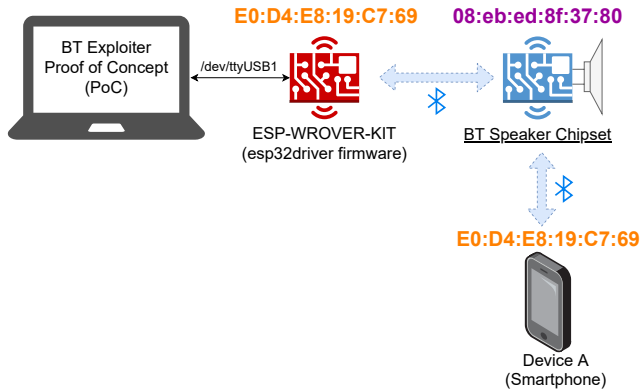
Figure 16: Same Host Connection

When reaching Actions Semi during the disclosure period, the company has informed us that they recommend the product vendors to only allow one audio BT connection. However, when we tested an ATS chipset based product *Xiaomi MDZ-36-DB*, we observed that multiple BT connections are allowed, albeit only one device can play audio at a time. Normally, connections with repeated host BDAAddress are rejected on *LMP Setup* procedure (c.f., Figure 1). However, this procedure is successful when testing *Xiaomi MDZ-36-DB* with repeated host BDAAddress, leading the audio device to an undefined state.

Impact: An attacker in radio range can exploit this vulnerable behaviour to perform DoS and intentionally deadlock the target device.

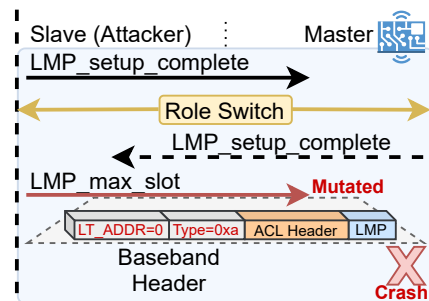
Figure 18: Invalid Max Slot Type

The Bluetooth Classic implementation in the Cypress WICED BT stack 2.9.0 [12] and earlier for CYW20735B1 [11] devices does not properly handle the reception of *LMP_max_slot* with an invalid Baseband packet type and *LT_ADDRESS* (see *Type* and *LT_ADDR* fields in Figure 18). The vulnerability is triggered after completion of the LMP setup procedure,

allowing attackers in radio range to trigger a denial of service (firmware crash) via a crafted LMP packet.

Impact: An attacker in radio range can exploit this vulnerable behaviour to perform DoS and intentionally crash the target device.

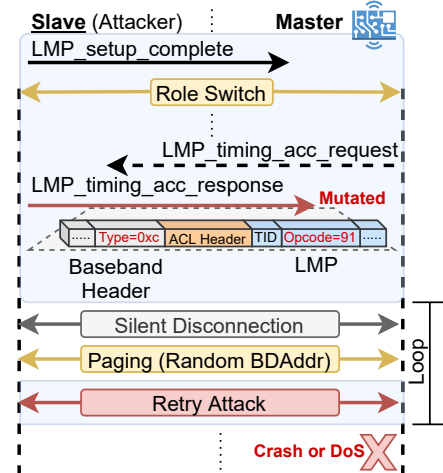
Figure 20: Invalid Timing Accuracy

[29] chipsets do not properly handle the reception of a malformed LMP timing accuracy response followed by multiple re-connections to the target link slave. This allows attackers to exhaust device BT resources. Eventually, the attacker can trigger a crash or BT disturbance via multiple attempts of sending a crafted *LMP_timing_acc_response* (i.e. LMP timing accuracy response) followed by a sudden reconnection to the target with a random BDAAddress.

Impact: This attack causes a denial of service (DoS) attack. Specifically, while the attack is in progress, the target devices are unable to use the Bluetooth service normally.

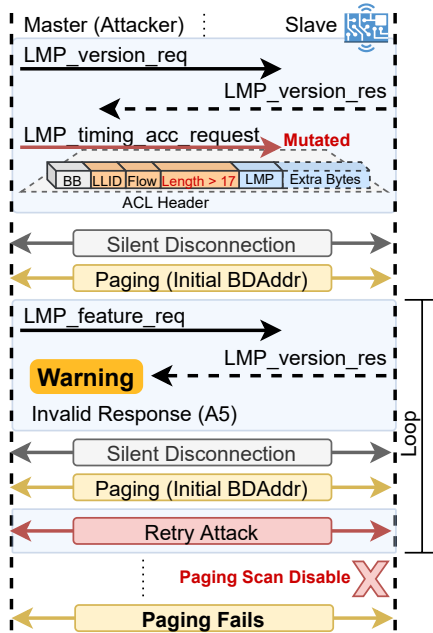
Figure 21: Paging Scan Disable

This vulnerability is depicted in Figure 21. As shown in Figure 21, sending an invalid packet during the LMP timing accuracy procedure (i.e. packet *LMP_timing_acc_request*), followed by a forced re-connection with the same BDAAddress

(any arbitrary BDAAddress of choice of the attacker), leads Intel AX200 to reject any externally initiated BT connections for an undetermined amount of time. This persists even after the attack stops and requires user intervention to recover AX200 normal functionalities.

Impact: Once the attack is triggered and successful, the attacker can cause DoS via the following AX200 behaviours: (I) paging scan is disabled, which prevents any external de-

vice to connect to the target even if the BDAddress is known. This behaviour can be used to trick an user to connect to the attacker’s BT hardware instead of the legitimate target since **AX200** paging scan is disabled; **(II)** Multiple active BT connections cannot be performed from the target. The user requires to manually restart the Bluetooth service to restore normal BT behaviour. On Linux and Windows, BT is recovered by disabling and enabling Bluetooth via their respective configuration menu.

Firmware crashes may be sporadically triggered on **AX200** during the attacks, but no specific scenario was found to reliably trigger such crashes all the time.
