BRAKTOOTH: Causing Havoc on Bluetooth Link Manager

VULNERABILITY DISCLOSURE REPORT

August 31, 2021

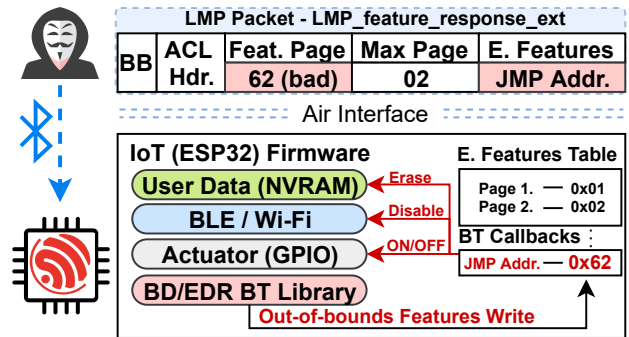
The most critical vulnerability (V1 in Table 2 - 8.1) affects ESP32 SoC [30], which is used in many Wi-Fi and Bluetooth IoT appliances such as Industry Automation, Smart Home, Fitness, etc. The attack is illustrated in Figure 3. A lack of out-of-bounds check in ESP32 *BT Library* [9] allows the reception of a mutated *LMP_feature_response_ext*. This results in the injection of eight bytes of arbitrary data outside the bounds of *Extended Feature Page Table* ("E. Features Table" in Figure 3). An attacker, which knows the firmware layout of a target device, can write a known function address (*JMP Addr.*) to the offset pointed by *Features Page* ("Feat. Page" in the *LMP_feature_response_ext* packet) field. It turns out that the *BT Library* stores some callback pointers within the out-of-bounds *Features Page* offset and such a callback is even-

tually invoked during the BT connection. While exploiting this vulnerability, we forced ESP32 into erasing its NVRAM data (normally written during product manufacturing) by setting *JMP Addr.* to the address of *nvs_flash_erase*. Such erase function is always included in ESP32 SDK [7] and therefore, it is present in any ESP32 firmware. Similarly, disabling BT or BLE can be done via *esp_bt_controller_disable* and Wi-Fi via *disable_wifi_agc*. Additionally, general-purpose input/output (GPIO) can be controlled if the attacker knows addresses to functions controlling actuators attached to ESP32. As expected, this has serious implications if such an attack is applied to Bluetooth-enabled Smart Home products.

Figure 3: An Illustration of CVE-2021-28138.

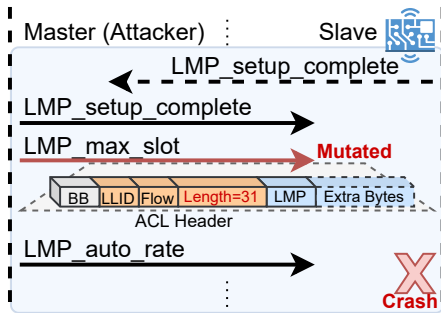
The Bluetooth Classic implementation in the Cypress WICED BT stack 2.9.0 [12] and earlier for CYW20735B1 [11] devices does not properly handle the reception of *LMP_max_slot* with a higher ACL Length (*Length=31* as shown in Figure 19) after completion of the LMP setup procedure. This allows attackers in radio range to trigger a denial of service (firmware crash) via a crafted LMP packet.

Figure 19: Max Slot Length Overflow
